## Field Evaluation of Ultra-High Pressure Water Systems for Runway Rubber Removal

Aaron B. Pullen, Lulu Edwards, Craig A. Rutland,  
and Jeb S. Tingle

April 2014

Final report

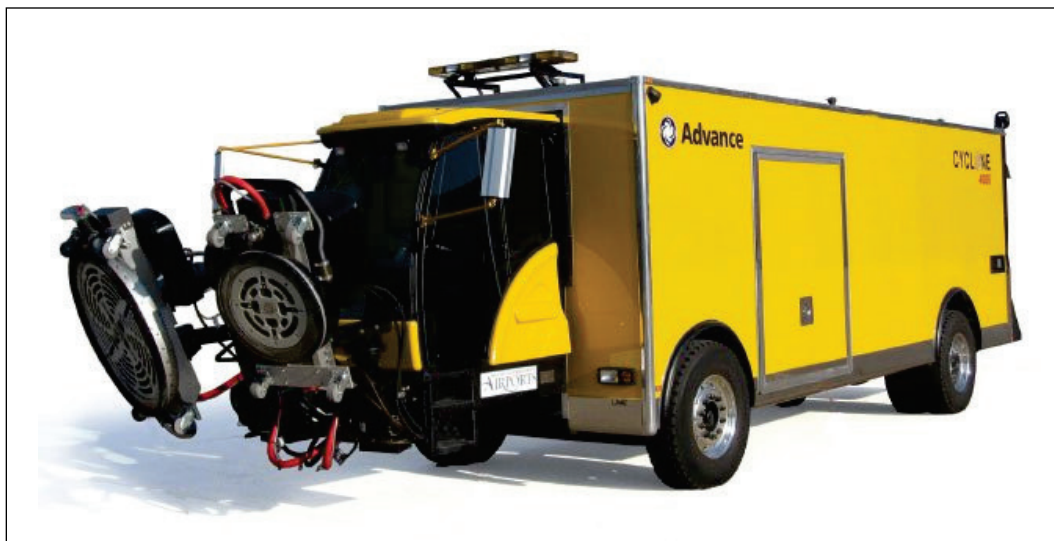
Figure 5. Cyclone 4006 rubber removal system.

The system as tested had a 36-in.-diam cleaning head, powered by a Tier III turbocharged liquid cooled engine, residing in a cast aluminum housing. This system has a debris recovery system which uses cyclonic action in conjunction with a macerator pump to pump runway contaminants to a galvanized reclamation tank with powered dump and powered door for easy maintenance. The Cyclone 4006 can be operated by a single operator using a joystick controlled hydrostatic drive. Water is pumped at 6 gallons per minute (gpm) at operating water pressures of up to 43,000 psi for rubber removal. The 30-ft-long by 10-ft-tall by 8-ft-wide vehicle had a maximum travel speed of 12 miles per hour (mph). The Cyclone 4006 houses a 1,600-gal fiberglass water tank. The entire system has a dry weight of

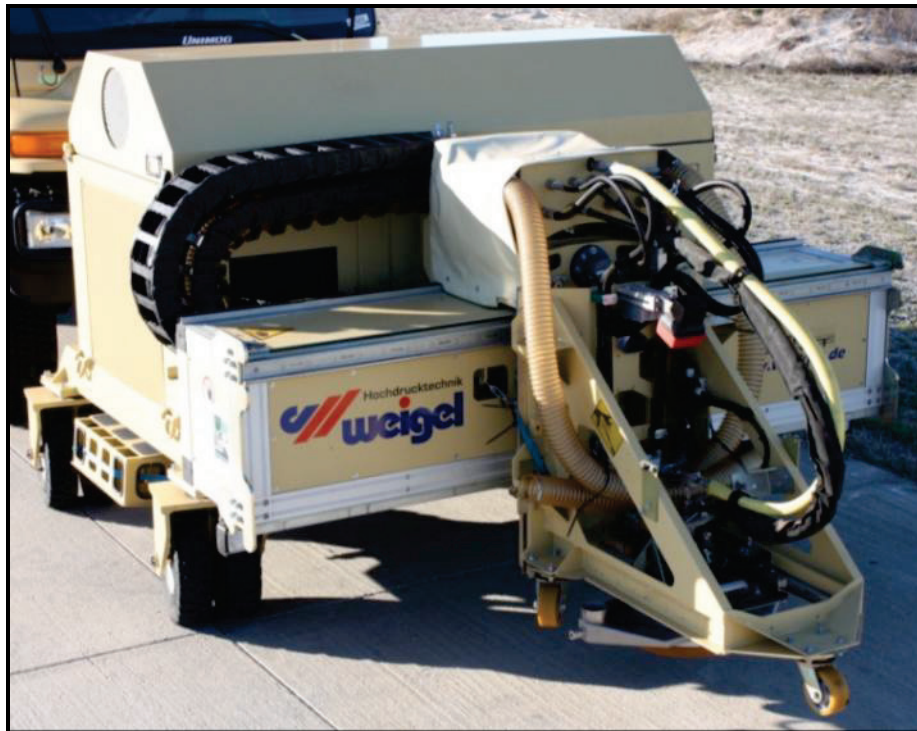
Figure 8. Trackjet cleaning module.

The Trackjet cleaning module is shown in Figure 8. The 7.87-in. blasting head is housed in this unit and has an 86-in.-wide cleaning path. Potable water is filtered to 1  $\mu$ m and pumped at 6.34 gpm to the blasting head. The blasting head is attached to a hydraulic driven swivel joint, which rotates and translates about a track. The maximum operating pressure of the blasting head is 36,000 psi.

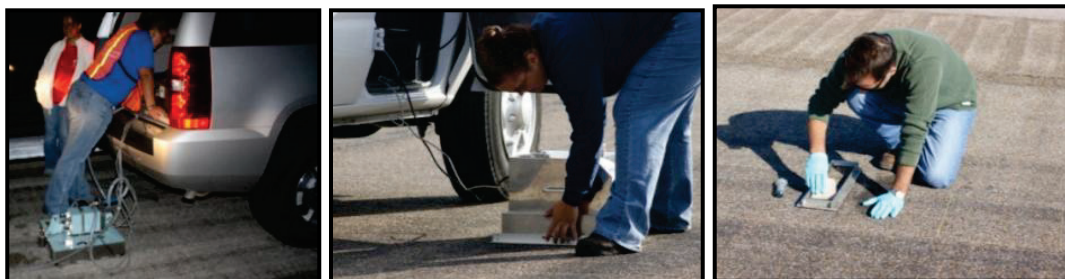
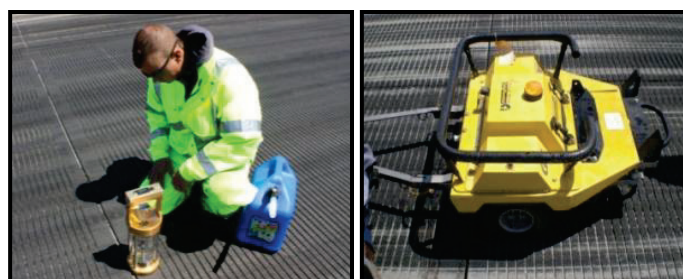
Figure 9. Pavement surface characteristics measurements.

Pavement macrotexture was measured with both the circular track meter (CT meter) and National Aeronautics and Space Administration (NASA) volumetric grease smear method. Pavement surface drainage capability was measured with an outflow meter. A GripTester MK1 C-type continuous friction measuring device performed full-scale friction tests. The dynamic friction (DF) tester measured a continuous spectrum of dynamic friction coefficients and international friction index (IFI) calculations at a given spot. These methods are shown in Figure 9.

DF Tester CT Meter NASA grease smear test

Outflow Meter GripTester®

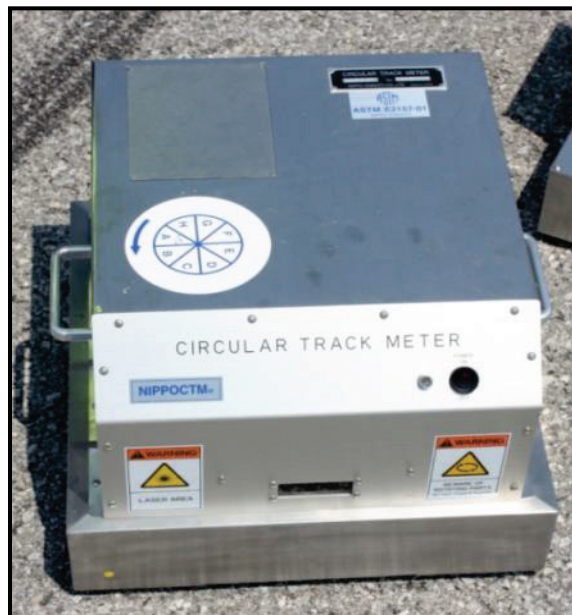
Figure 10. Circular track meter.

Figure 10 shows the CT meter, also known as the circular track meter. The CT meter uses a laser displacement system to measure the vertical profile of a pavement surface, giving an indication of pavement macrotexture (ASTM E 2157 (American Society for Testing and Materials International 2009c)). The CT meter has integrated software which calculates and reports mean profile depth (MPD) and root mean square (RMS) values. This unit collects measurements over an 11.18-in.-diam area, covering the same footprint as the DF Tester.

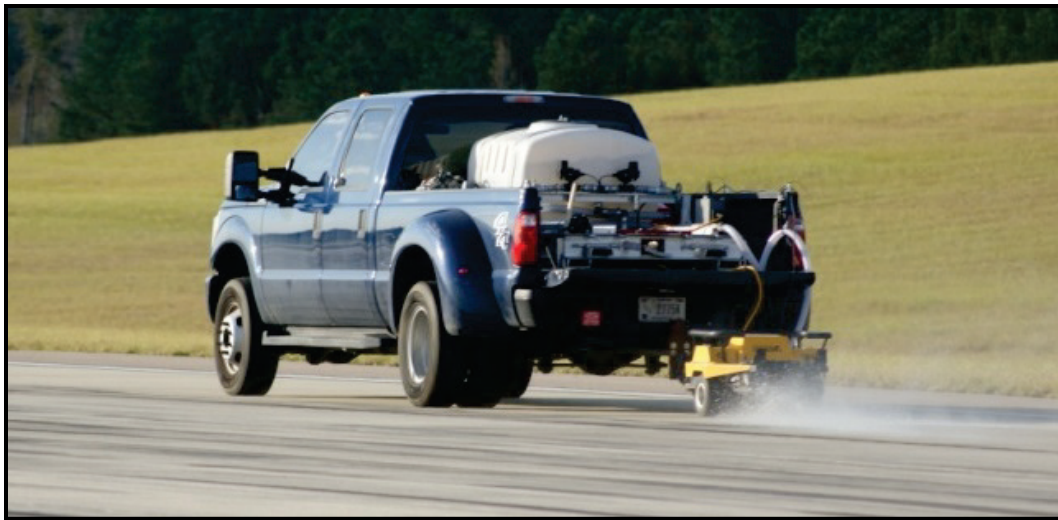
Figure 12. GripTester MK1 C-type.

As the GripTester is in tow, the measuring tire is slipped by a chain drive transmission from the primary two-wheeled axle. Dynamic friction readings are calculated from strain gauge data and are stored in a computer tethered to the GripTester by serial cable. Movement of a drive sprocket on the front axle is measured by an inductive proximity sensor. These data determine speed and distance during operation. The on-board computer calculates and stores the survey speed for each 32.8 ft of friction readings.

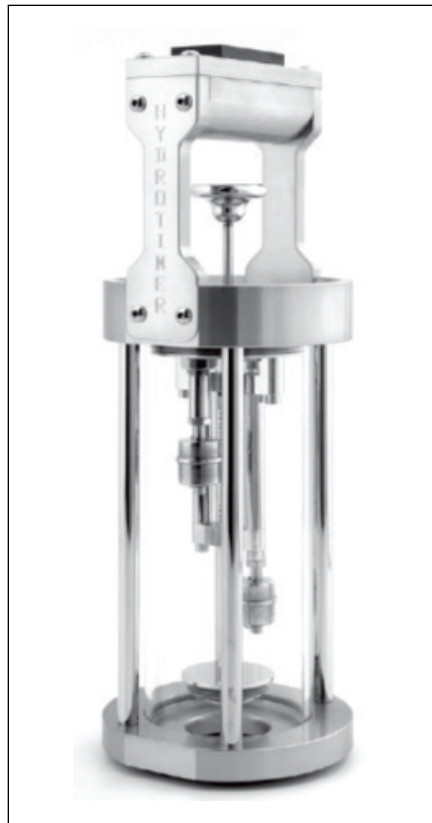
Figure 13. Hydrotimer outflow meter.

The Hydrotimer is a patented and self-contained outflow meter. Its operation is simply a drain-down test with the primary purpose of checking water drainage through texture voids in pavement surfaces. A rubber sealing ring mounted on its base for contacting the surface insures zero outflow when a test is conducted on a glass smooth surface. Therefore, a test conducted on a surface with inter-connected texture voids will result in an incomplete seal and an outflow of water. The measured volume of water is timed by on-board electronics with a liquid crystal display (LCD). A measured volume of water is released in the center of the sealing ring while an electronic timer measures elapsed time for the water to pass through texture voids in the pavement under the seal. The Hydrotimer outflow meter is shown in Figure 13. Higher time readings indicate smooth surfaces with poor macrotexture, such as a piece of glass or a heavily rubber contaminated runway. Shorter time readings indicate surfaces with good macrotexture, such as areas where rubber is removed.

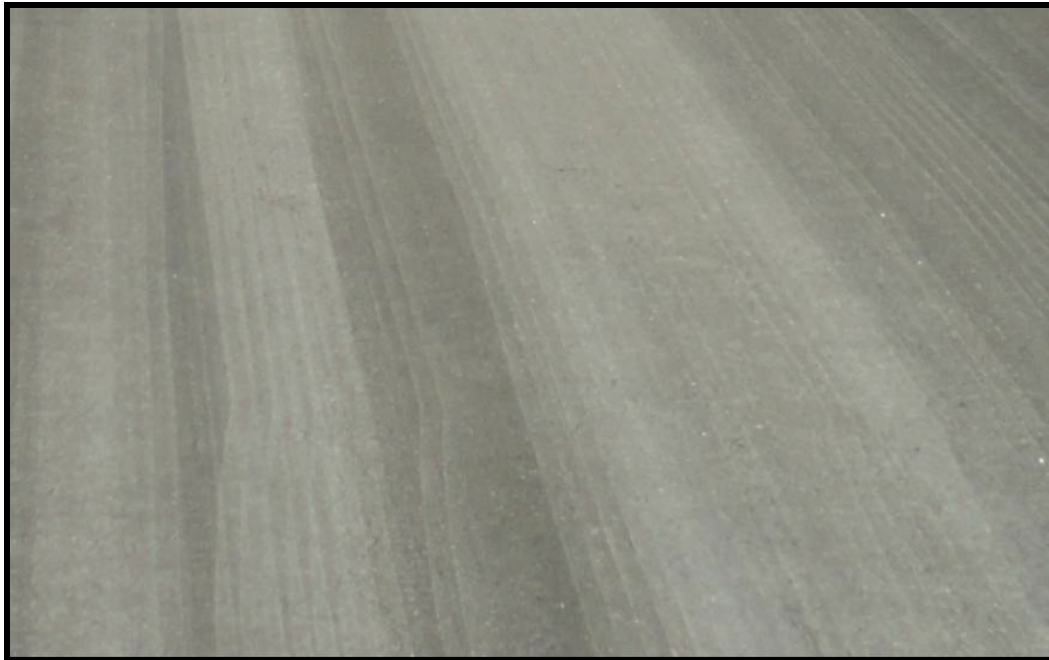
Figure 24. Typical pavement surface on Runway 22L after Cyclone 4006 rubber removal.

Figure 24 presents a typical pavement surface on Runway 22L after Cyclone 4006 rubber removal. Cyclone 4006 rubber removal produced a uniformly clean pavement with some light staining, but the pavement surface is visibly free of rubber deposits.

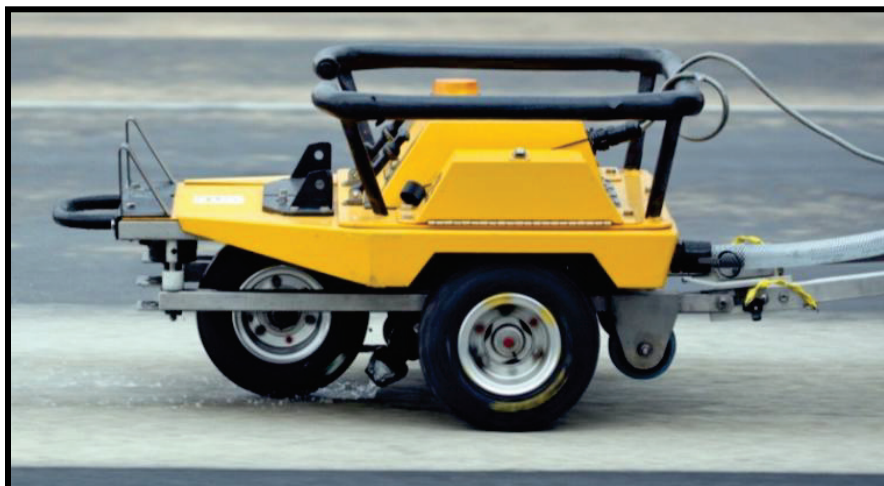
Figure 27. Findlay Irvine GripTester MK1 C-type.

Figure 27 shows the GripTester used to collect friction measurements on Runway 22L. Friction surveys were conducted on areas identified as having the heaviest rubber buildup, 8 ft on both sides of the runway center line as indicated in Figure 28. Surveys were conducted at speeds of both 40 mph and 60 mph.

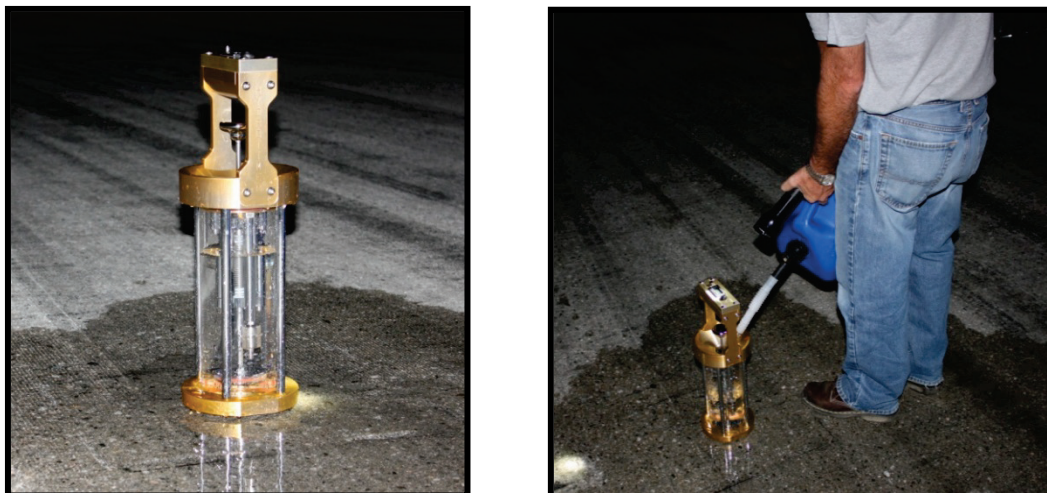
Figure 55. Outflow time measurements.

Outflow meter tests were performed prior to and after rubber removal at the same location in each test section. Outflow time (OFT) is the measured parameter for this test. OFT is the length of time required for a volume of water to pass between a rubber seal and the surface of the pavement. Surfaces with smooth macrotexture, such as a pane of glass, would result in high OFTs. Shorter OFTs are anticipated after rubber removal, as shorter test times indicate a rough macrotexture and better surface drainage. Outflow meter testing is shown in Figure 55.

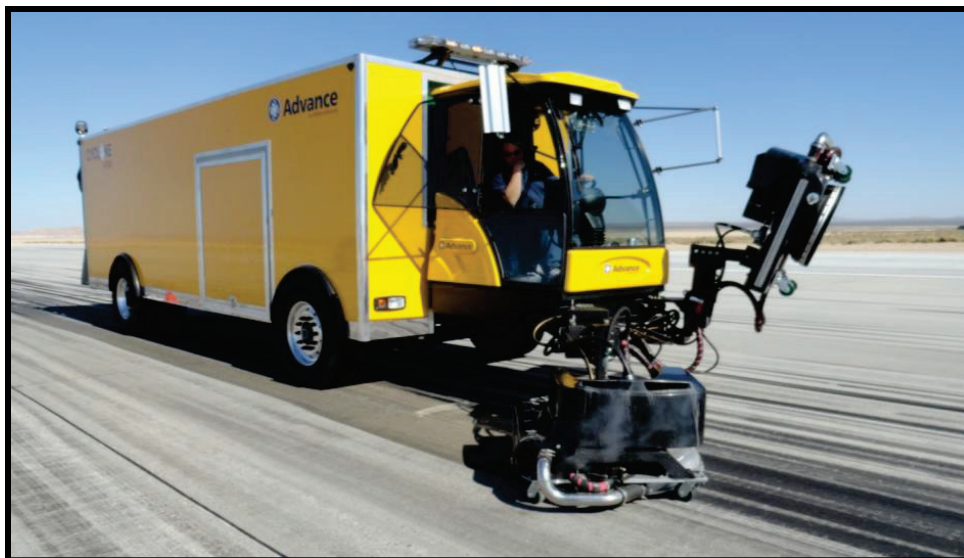
Figure 66. Cyclone 4006.

The Cyclone 4006, shown in Figure 66, operated each shift without work stoppage or maintenance after filling with water from an infield fire hydrant and performing a nozzle check. The Cyclone 4006 operates noticeably quieter than the SH8000R and Trackjet, as it does not employ the use of vacuum for debris recovery. The slurry of rubber and water collected during rubber removal is slung to the outside of the cleaning head and then pumped via a macerator pump to a chamber where solids and liquids are separated.

The macerator pump and the resulting quieter operation of the unit is a technology that offers additional military and operational utility which should be further tested and developed. The unit could be operated without hearing protection; personnel in the cab were able to converse on a radio while the machine was operating which may allow teams operating this unit to meet mission requirements with fewer personnel. Units using suction to remove water and debris are loud enough that a driver concentrating on the operation needs one person to follow along the outside to ensure the unit is not damaging pavement, and one person to be far enough away that they can safely operate and monitor a radio and be close enough to the operation to ensure the unit can respond within seconds to either in-flight emergencies or attacks on the airfield by combatants. The quieter operation of the unit may also make it more difficult for combatants to target the airfield.

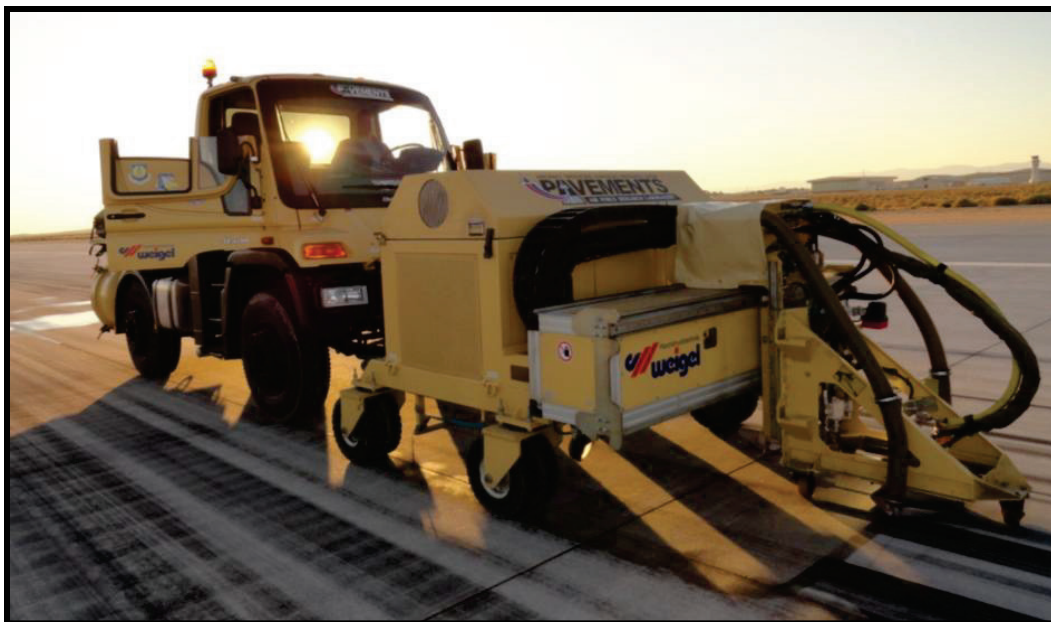
Figure 71. Trackjet removing rubber on Runway 22L.

The Trackjet system used for testing was purpose-built for C-130 aircraft transport. Some components on the Trackjet are scaled down for the unit to meet air transport weight and dimensional requirements. With a smaller platform vehicle, water reservoir, and vacuum recovery chambers, this system has limited production compared to full-scale production oriented Trackjet models. The Trackjet is shown removing rubber on Runway 22L in Figure 71.

The U400 Unimog platform vehicle did not provide adequate power to the Trackjet for this test. To aid preventing the engine from overheating, the heater inside the cab of the Unimog had to constantly run. The Unimog doors are open in Figure 71 for operator comfort. The average ambient temperature during testing was 80.7°F.

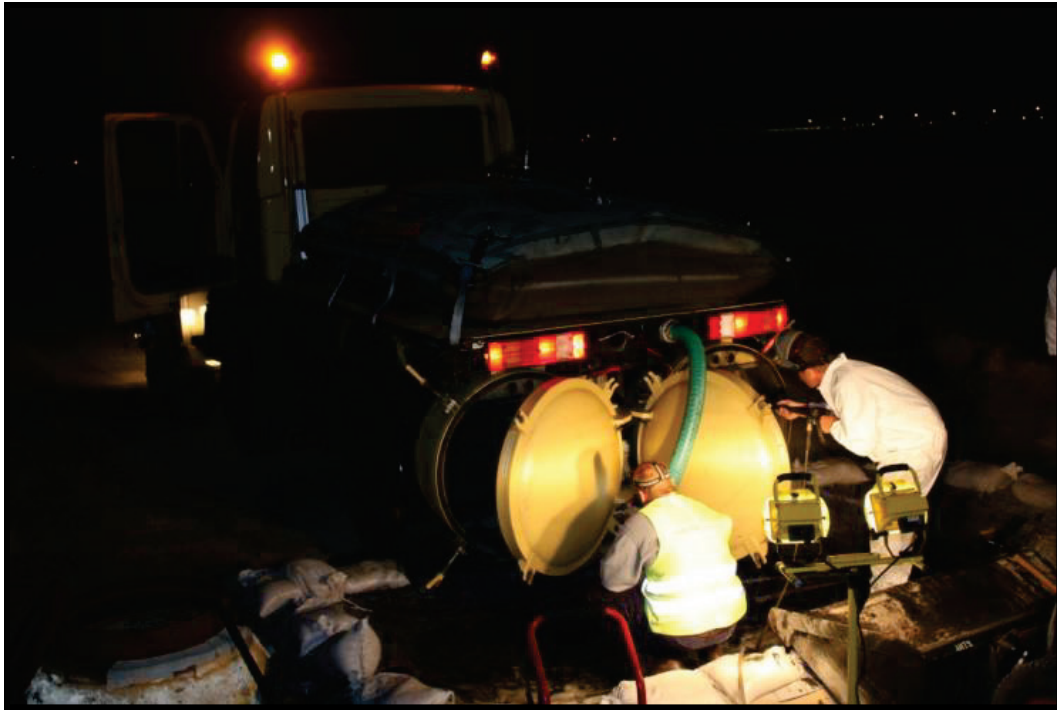
Figure 72. Trackjet cleanout.

Solid wastes have to be removed frequently from two vacuum chambers at the rear of the Unimog due to the scaled-down design of its debris recovery system. Cleaning the vacuum chambers requires a designated cleanout area set up to handle the process. Figure 72 shows the Trackjet cleanout process. A generator, halogen lights, a pressure washer, shovels, a sump pump, and container to transfer solids were used to support the cleanout process. A berm lined with heavy plastic and sandbags was constructed to capture gray water during this cleaning. Mesh filters in each chamber had to be thoroughly cleaned by high pressure water in order for the chambers to maintain adequate vacuum pressure for debris recovery. Figure 73 shows solids collected in a Trackjet vacuum chamber.

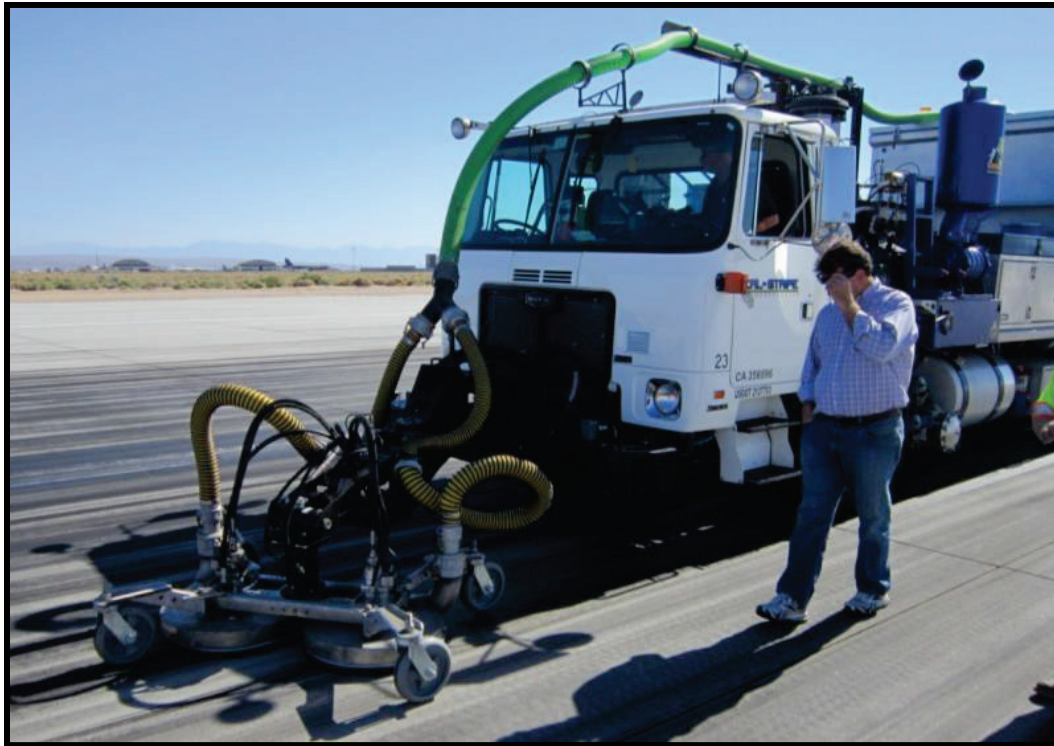
Figure 74. SH8000R removing rubber on Runway 22L.

The SH8000R is outfitted with two cleaning heads supplied with a 12-gpm flow rate, approximately twice the flow rate used by the Cyclone 4006 and Trackjet technologies. The SH8000R used the least water and had the highest production rate.

In select areas, the SH8000R operator had difficulty establishing an effective combination of water pressure and speed settings to achieve a uniformly clean pavement surface. Inadequate settings contributed to a less than uniform distribution of water at the pavement surface, resulting in some rubber deposits left on the runway. In this case, it was often difficult to determine if rubber was simply being left on the pavement or if water jets were lightly etching the pavement surface. An example of this condition is shown in Figure 75. Evidence of light scoring was found behind the SH8000R in one isolated area. This pavement damage area is shown in Figure 76. Once noted by the researchers, this issue was corrected by the contractor. It was noted that one of the shrouds was damaged while the unit was cleaning near the aircraft arresting system.

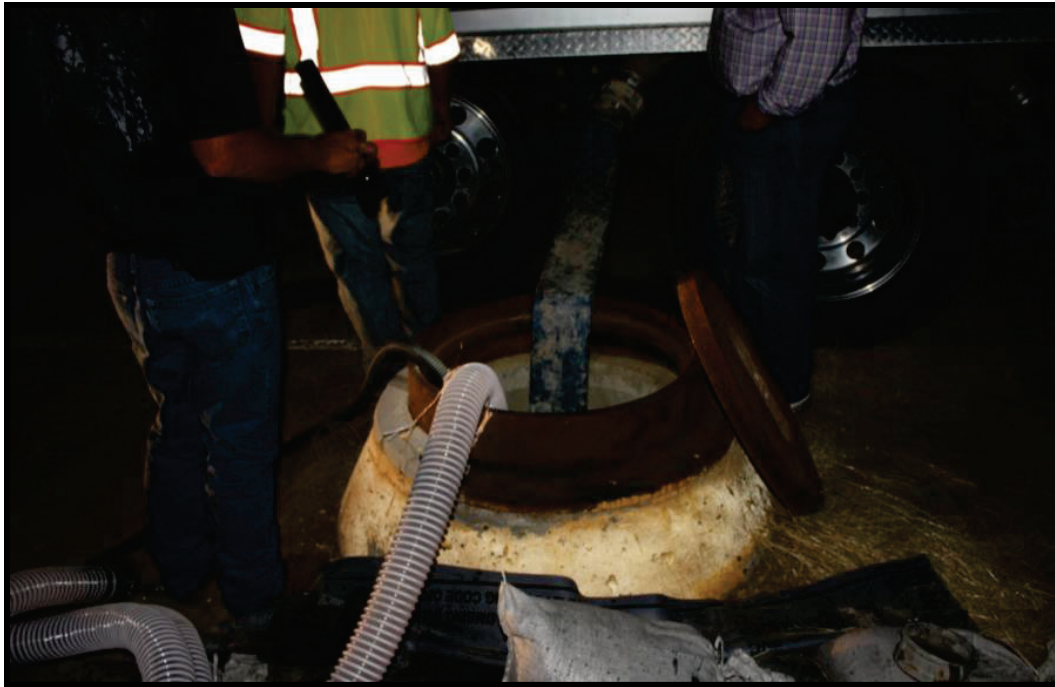
Figure 77. SH8000R gray water discharge.

The SH8000R gray water discharge process is shown in Figure 77, and the dump process is presented in Figure 78. The dump process required two individuals at the rear of the bed to dislodge solids resting on a fabric material.
